Performance of Industrial-Type Cladding Materials

Gerald A. Sleater

March 1973

Final report describing work performed from June 1969
through May 1972.

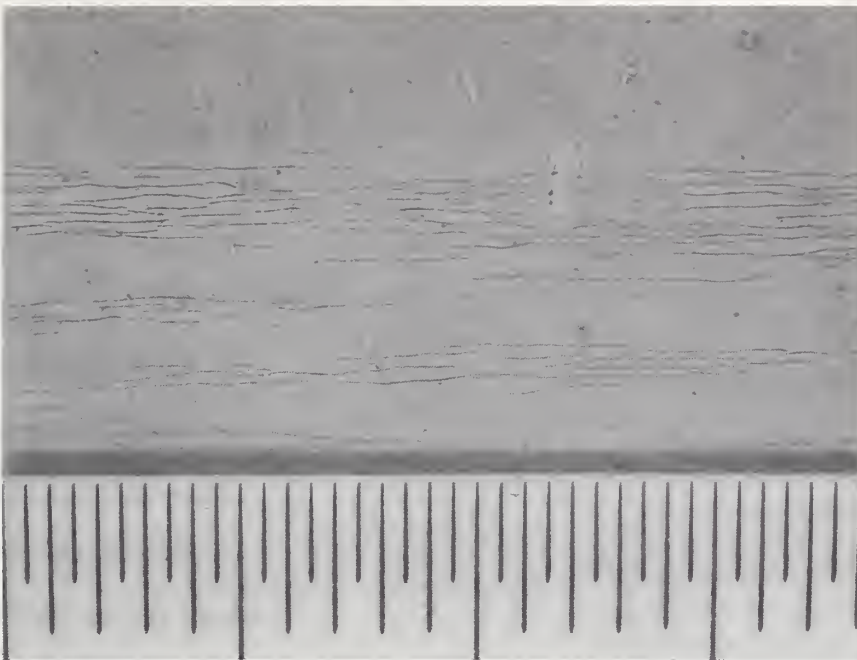
Fig. 4 - Cracks along bends of untested cladding panel.
Scale divisions, 0.5 mm. (A.5)

The severity of the salt spray test for claddings is illustrated in figures 4 and 5. In the section of untested cladding specimen pictured in figure 4, cracks in the coating extended along the longitudinal panel bend. Use of a holiday detector indicated that these cracks penetrated to the substrate. After 150 hours in a 5% salt spray atmosphere at 94°F, the coating along these cracks had blistered and some had flaked off (figure 5).

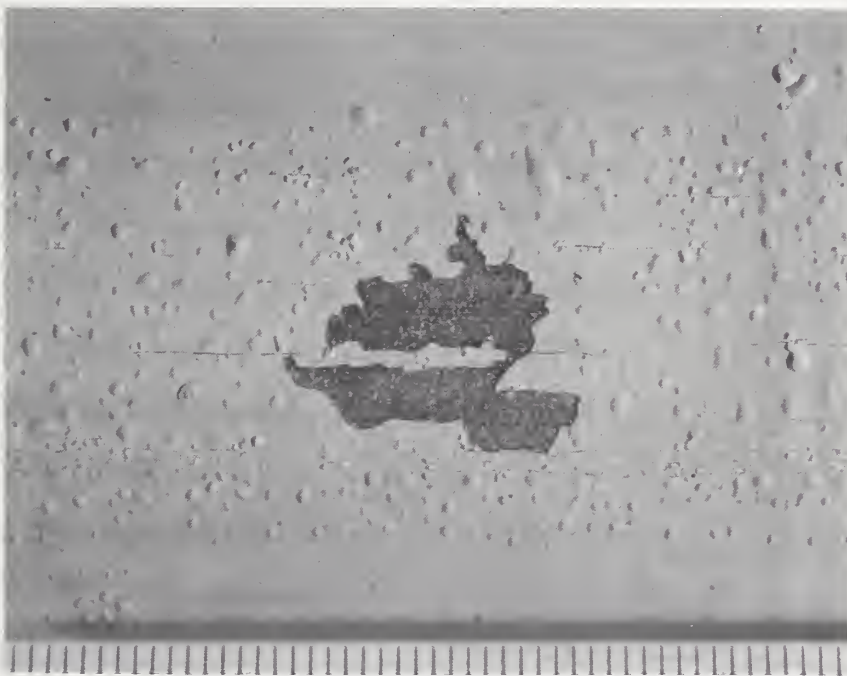
Fig. 5 - Section of cladding panel pictured in figure 4
after 150 hours in 5 % salt spray at 94° F.
Scale divisions, 0.5 mm. (A.5)

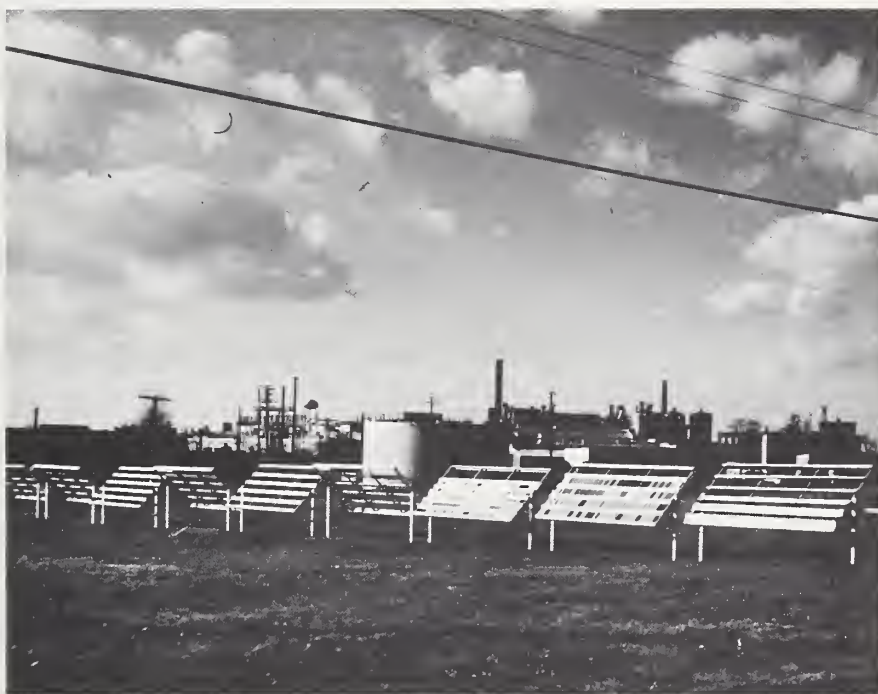
Fig. 9 - NBS Exposure Station at Fort Holabird, Baltimore Maryland in 1970. (B.1)

All exposure stations are in essentially rural locations on U. S. Government reservations, with the aforementioned exception of the Fort Holabird exposure station, pictured in figure 9. At Fort Holabird, in an industrial zone of Baltimore city, windborne particulate matter and air pollution are major factors in the weathering process.

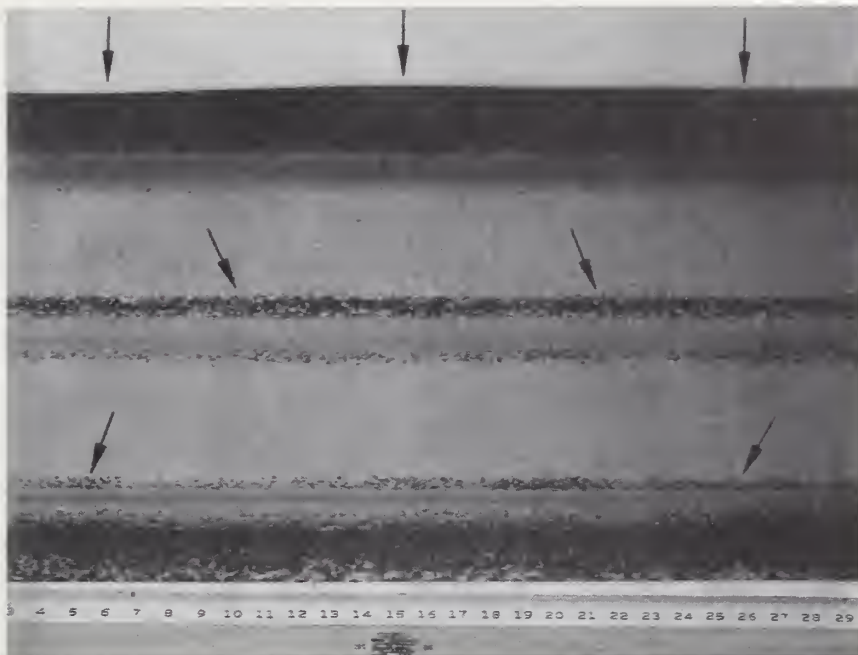
Fig. 20 - Cladding panel exposed 19 months at Cape May, N.J. (seaside site). Arrows indicate areas where substrate is corroded. Scale in centimeters. (B.3)

An example of almost complete coating degradation is illustrated in figure 20. The specimen's exposure conditions were also 19 months at the New Jersey 80 foot site. There has been considerable color fade, chalking, and pitting of the coating, with substrate corrosion both at the panel bends and at the cut edges.

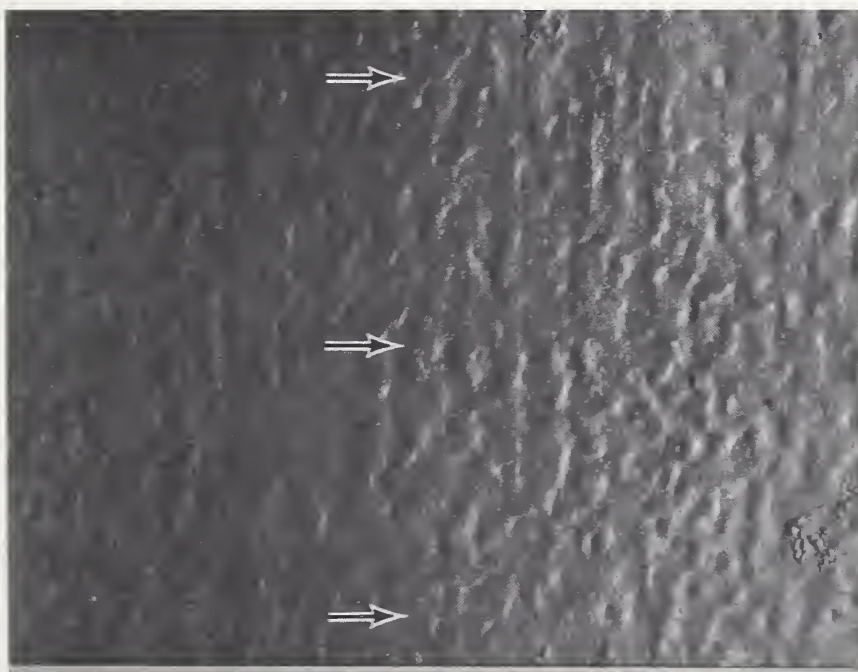
Fig. 21 - Cladding panel exposed 19 months at Cape May, N.J. (seaside site). Panel surface protected by exposure rack is to the right of the arrows. Scale divisions, 0.5 mm. (B.3)

Figure 21 illustrates a case of coating degradation in which the applied coating was evidently unstable to weathering. All specimens of this cladding system that had been exposed to natural weathering were found to be in poor condition. Before laboratory testing or natural weathering this siding system had cracks in the coating which holiday testing indicated penetrated to the metal substrate. Weathering caused considerable chalking, color change, blistering and pitting of the coating. This effect of weathering is best illustrated by a panel exposed for 19 months at the seaside New Jersey site. The arrows in figure 21 indicate the approximate line of demarcation between the darker area of the coating (to the left) that was open to weathering, and the lighter area (to the right) that was protected by the flap holding the panel on the exposure rack. Enlargement of a segment of this demarcation line is pictured in figure 22. Blisters formed under the flap were unbroken (downward arrows); blisters in the exposed area have broken, exposing the bare metal of the substrate (upward arrows); horizontal arrows indicate cracks in the coating.

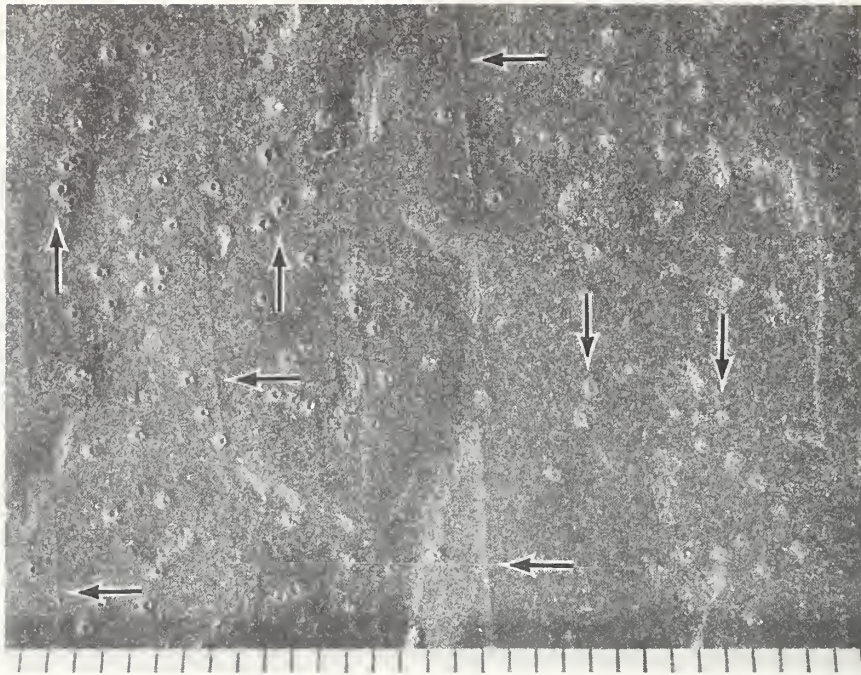
Fig. 22 - Enlargement of panel pictured in figure 21; downward arrows indicate unbroken blisters; upward arrows, broken blisters; horizontal arrows, cracks in coating. Scale divisions, 0.5mm 0.5 mm. (B.3)

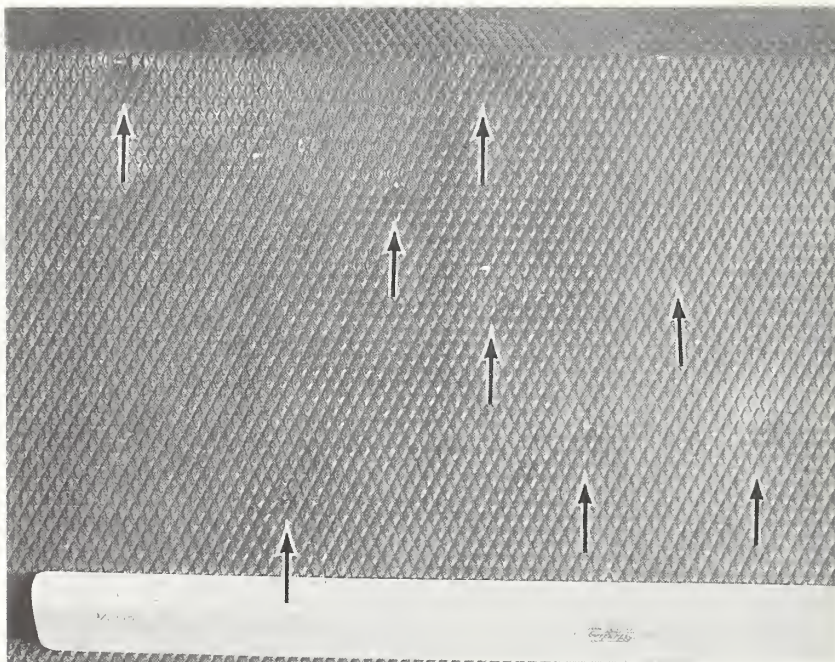
Fig. 23 - Surface depressions (arrows) in light gauge metal substrate cladding after 15 months natural weathering. (B.3)

The only instance of impact damage to cladding that occurred during natural weathering exposure is pictured in figure 23. The surface depressions in this panel of light gauge cladding (0.018 inch metal substrate) are thought to have been due to golf balls from a golf driving range near the exposure racks. (The racks have since been moved to another location.) Heavier gauge cladding, mounted adjacent to panel in figure 23, did not show this damage.

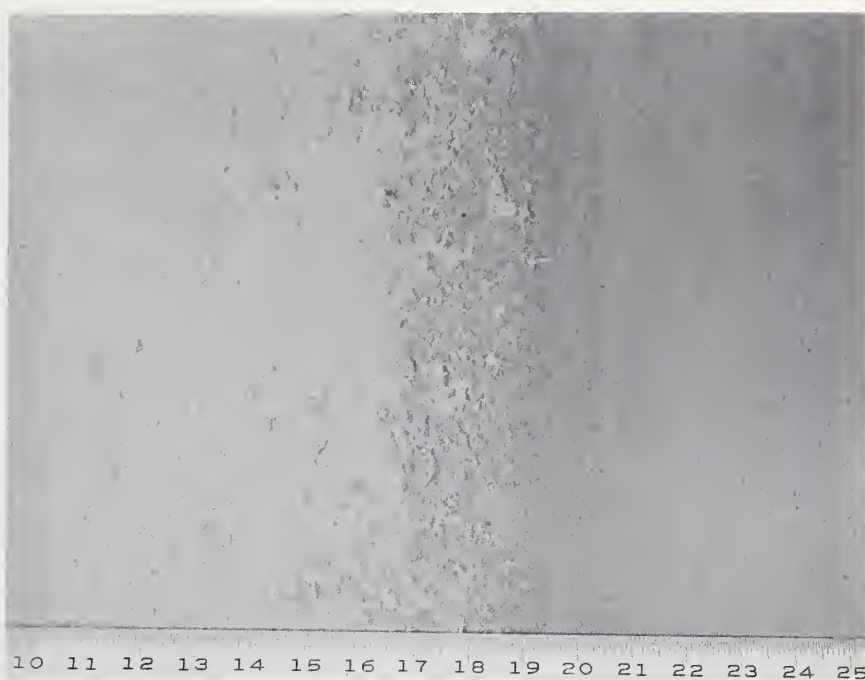
Fig. 24 - Cladding panel exposed 24 months, Gaithersburg, Md. Applied coating deteriorated by not removing protective film from panel. Scale in centimeters. (B.3)

One instance of coating degradation that occurred during natural weathering was caused, evidently, not by the environment or climate alone. When the panel pictured in figure 24 was mounted at the Gaithersburg exposure station, a factory-applied transparent plastic film, intended to protect the coating finish during transit and erection, was not peeled off. This protective film was removed from a panel of the same cladding mounted nearby. After two years of weathering, this latter panel showed no coating degradation. The panel on which the film had been left had serious degradation of the coating (figure 24). Where the panel was covered by the flap of the exposure rack some of the protective film was still present and the coating of the panel has not degraded (from 18 to 25 cm. on the scale in figure 24). Where the panel had been fully exposed to weathering (10 to 18 cm.), the protective film had weathered away and the applied organic coating had been seriously degraded. The exact nature of this degradation is not known, although it is evident that non-removal of the protective film was a factor in its cause.

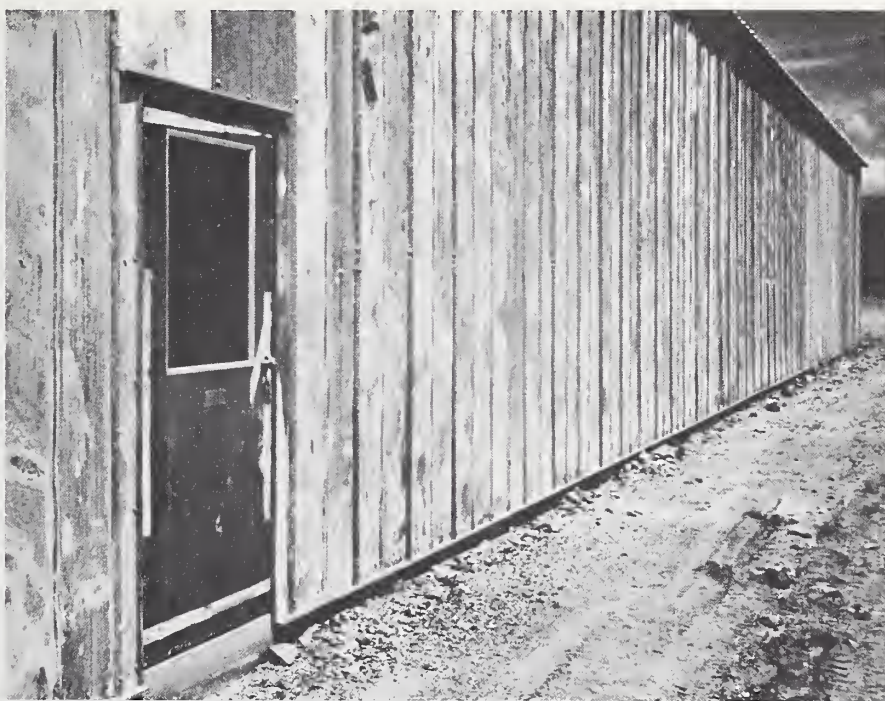
Fig. 25 - Building in Puerto Rico, constructed of non-coated metal cladding. (C.2)

The effect that climate can have upon uncoated metal cladding is illustrated in figure 25. This building, in Puerto Rico, was constructed of uncoated metal cladding; three months following erection, every siding panel was corroded. A nearby structure, constructed with factory-coated cladding, has, after three years weathering, wall panel corrosion only where the applied coating has been lost. In figure 26, one segment of the building wall, where corrosion has occurred in an area without coating, is pictured together with an adjacent coated panel.

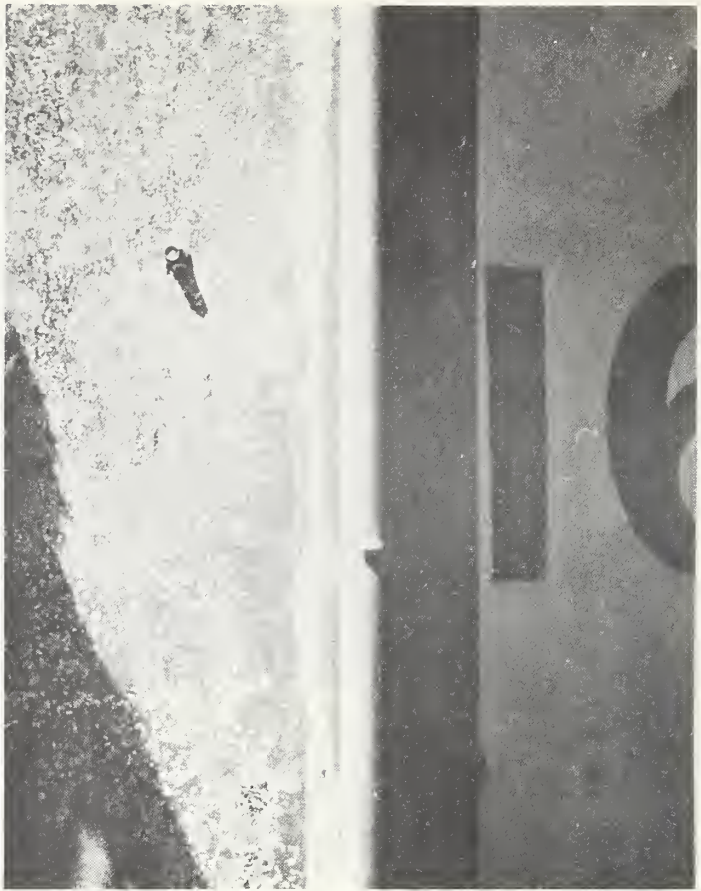
Fig. 27 - Cladding destroyed by corrosive industrial atmosphere (indicated by arrows). (C.2)

Some industrial environments afford corrosion problems that no cladding system can long protect against. For example, the cladding used to cover a steel mill hot-coke conveyor belt must be replaced biannually. The corrosive fumes from these coke ovens also attacked the cladding used in nearby storage buildings (figure 27). Another example of a severe though more localized industrial environment is shown in figure 28. Cladding over a heat exchanger exhaust was corroded, discolored, and mildewed. Nearby cladding remained in excellent condition.

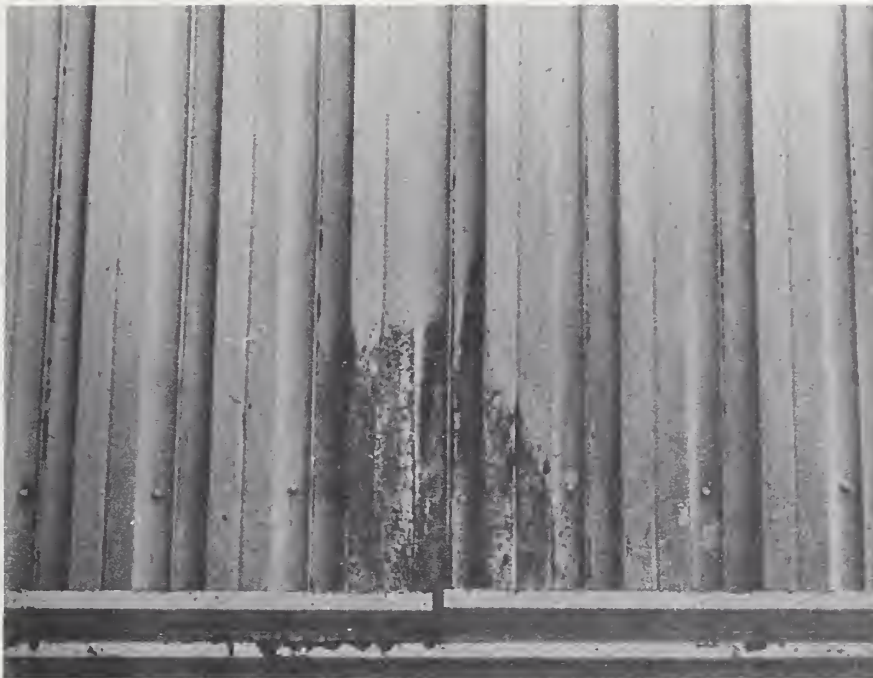
Fig. 28 - Cladding over a heat exchanger exhaust. (C.2)

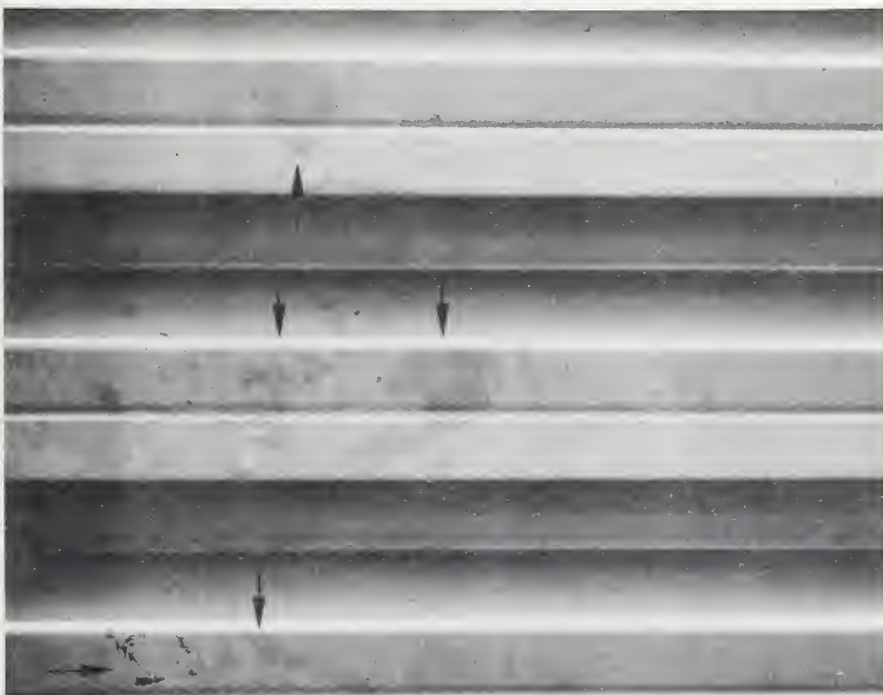
Fig. 29 - Cladding after 5 years near salt water, showing chalking (vertical arrows) and abrasion (horizontal arrow) of the applied coating. (C.2)

Salt water environments can present special problems both for the metal substrate and for the applied organic coating. The cladding pictured in figure 29 was used in a building located several hundred feet from an ocean inlet. After five years in service, the coating shows heavy chalking and slight color fade. Corrosion of the substrate has occurred where the coating was abraded. The airplane hangar pictured in figure 30 is in the same general area, within a mile of the ocean. In enlarging the facility an attempt was made to duplicate the color of the original cladding. Due to fading of the original coating, there was a significant difference in color between the new and old cladding (figure 31).

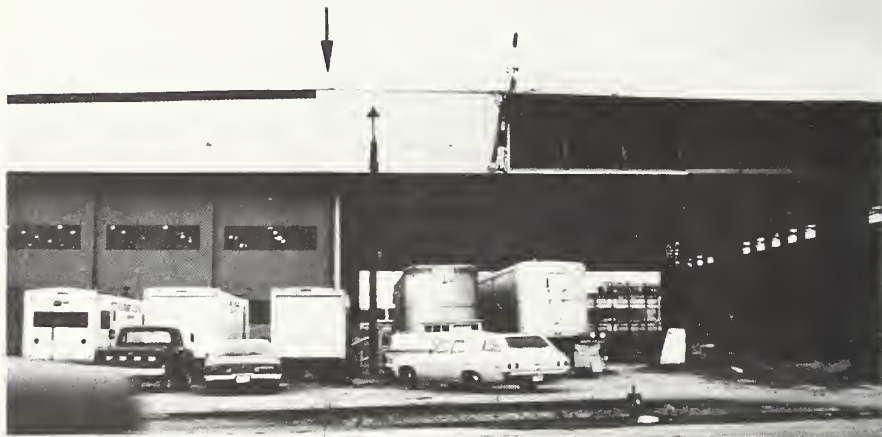
Fig. 30 - New cladding (to the right of the arrow), of same color as original cladding, being added to airplane hanger. (C.2)

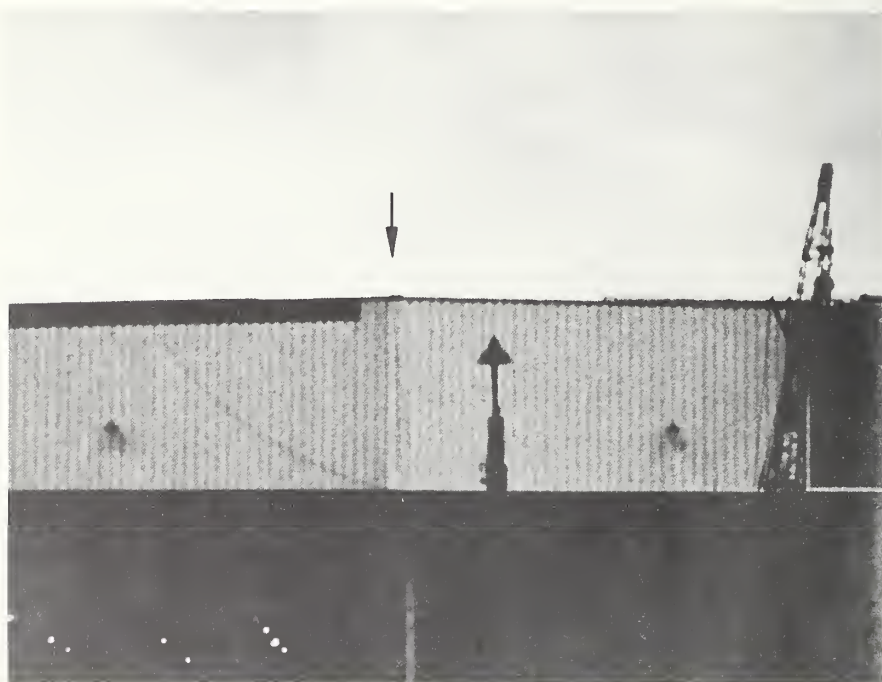
Fig. 31 - Enlargement of figure 30. Color of original cladding (left of arrow) is faded when compared to the identical color in the new cladding (right of arrow). (C.2)

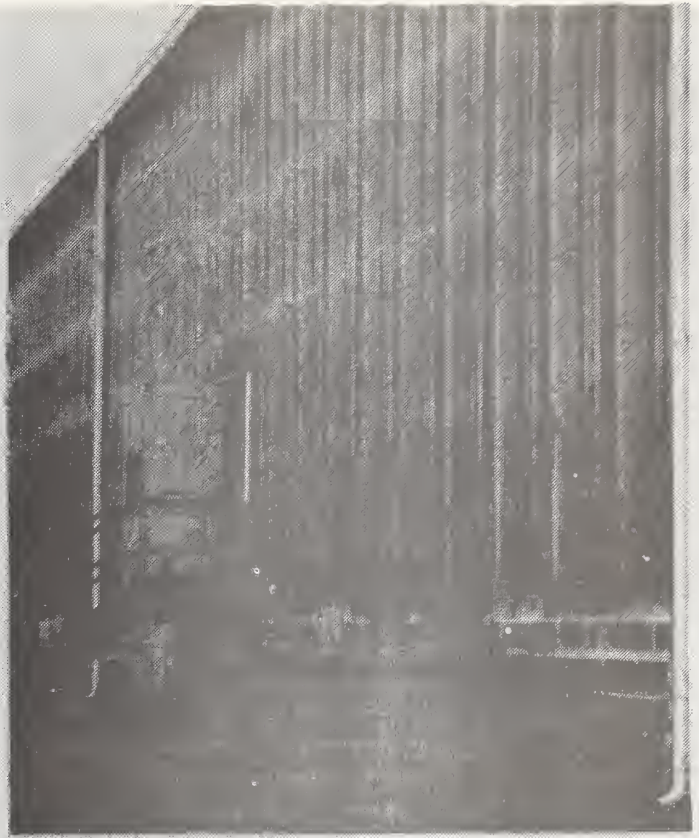
Fig. 32 - Building wall of industrial cladding with arrows indicating color fade of the applied coating. (C.2)

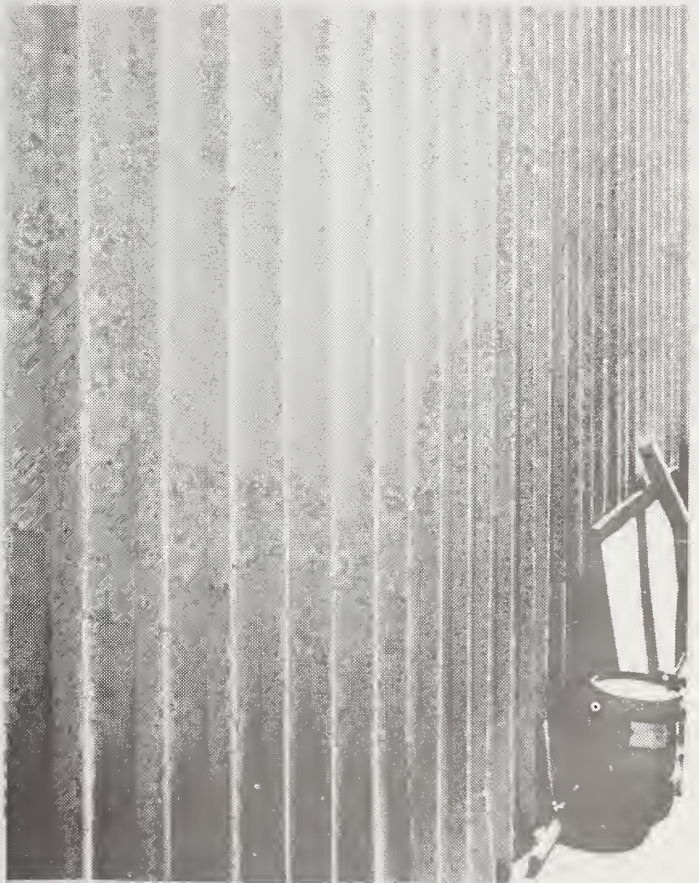
Fig. 33 - Industrial cladding damaged by hail. (C.2)

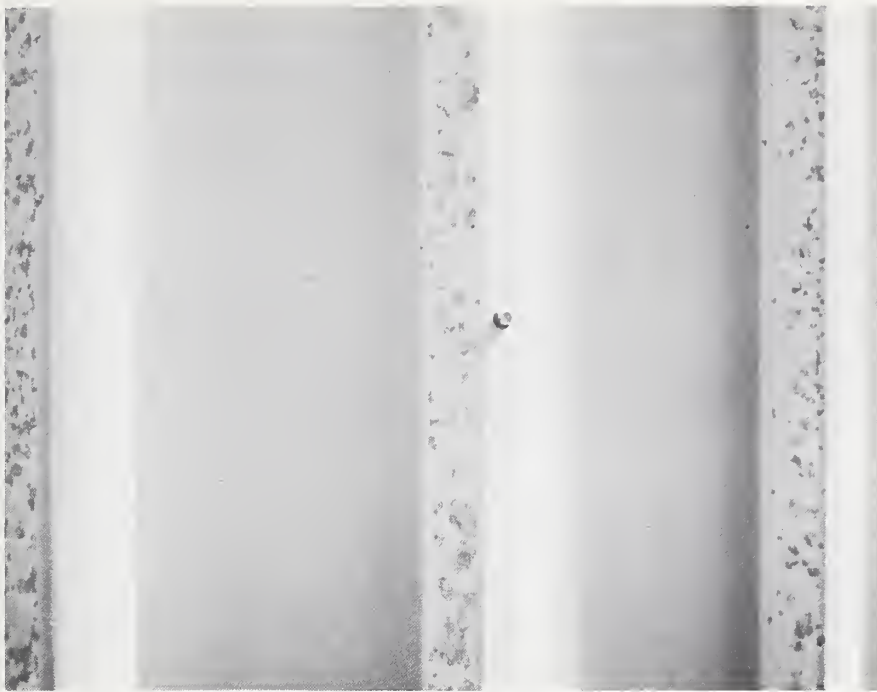
Fig. 34 - Close-up photograph of cladding damage pictured in figure 33, showing substrate exposed by hail impact. (C.2)

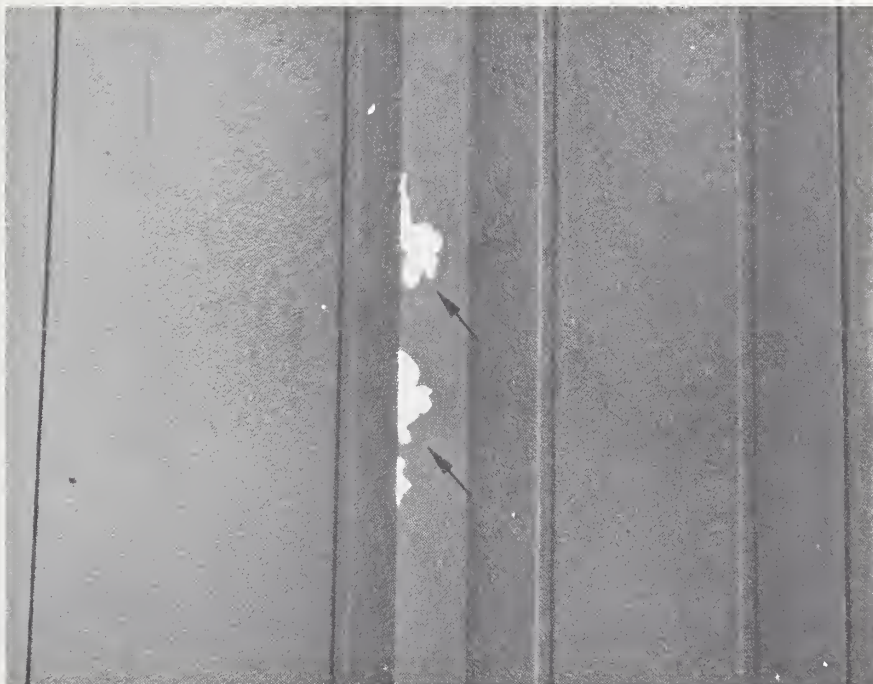
Fig. 35 - Spalling of applied coating (indicated by arrows) due to alleged improper preparation of substrate during factory coating. (E.2)

Spalling may occur when the coating manufacturer's recommendations for application of the coating to the substrate have not been followed. This is illustrated in figure 35. The wall panels and spacers have the identical coating, but according to the coating manufacturer's representative, the spacers were coated without the recommended priming of the substrate.

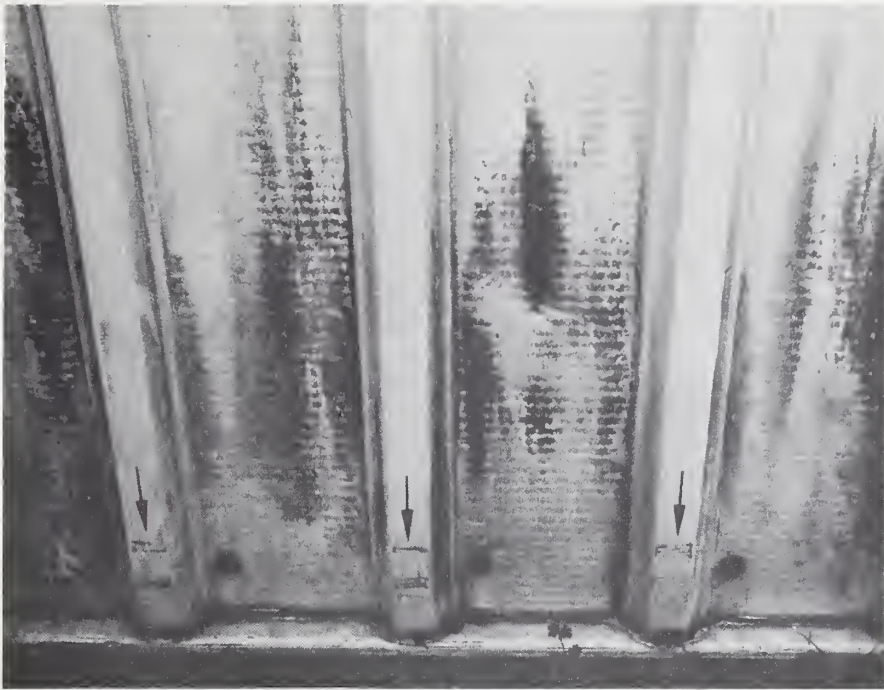
Fig. 36 - Abrasion of panel coating (indicated by arrows) by grass cutting machinery. Dark splotches on panels are from mildew. (E-2)

Where buildings were surrounded by grass plots and the wall cladding extended to ground level, there was a strong possibility for injury to the cladding from grass mowing. Such injuries were not only abrasions of the coatings (figure 36), but also deformations of the wall panels (figure 37). A gravel border contiguous to the building should eliminate injury from grass cutting by simply obviating its need. More serious was vehicle impact damage, which distorted or even dislodged cladding

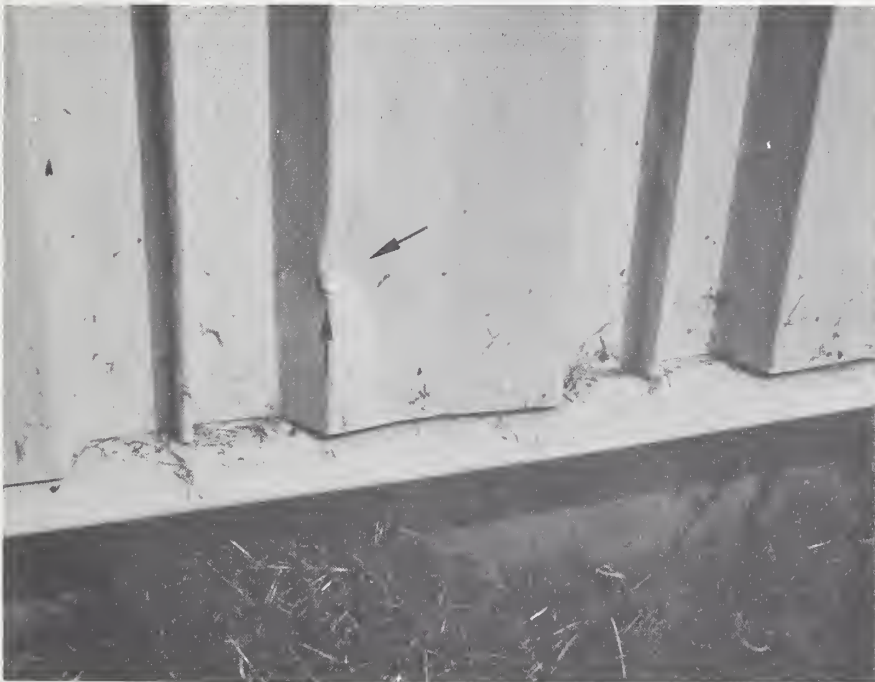
Fig. 37 - Deformation of wall panels (indicated by arrows) from grass cutting machinery. (E.2)

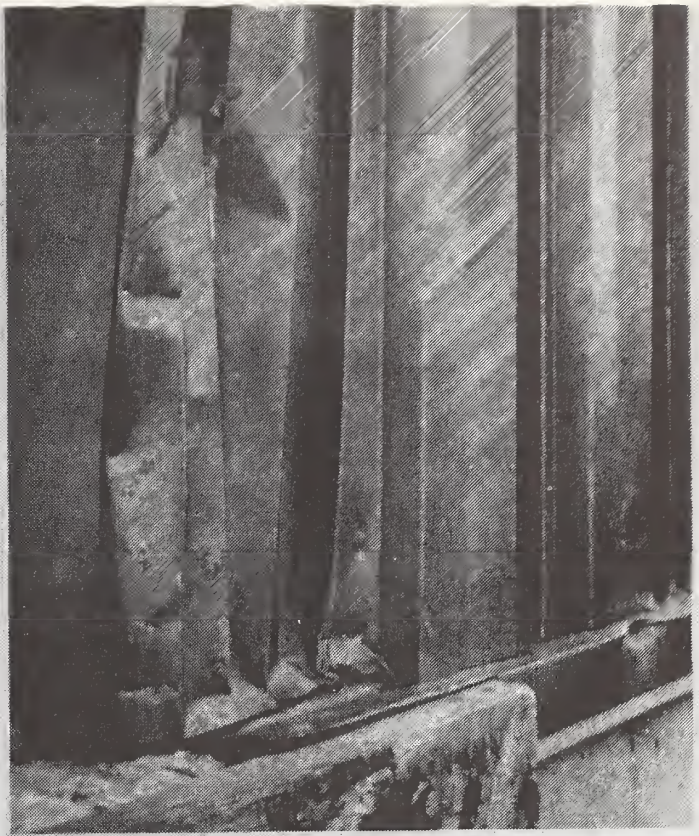
Fig. 38 - Damaged cladding
next to loading dock. (E.2)

panels from the structural supports. Cladding adjacent to loading dock areas was especially prone to this type of damage, as illustrated in figure 38. Any wall surface susceptible to impact damage should be protected either by a bumper system or incorporation of more robust building materials with the cladding. Such a combination of masonry and cladding in a loading dock area is shown in figure 39. Cladding damage may also be caused by vehicle use within a structure. The prongs of the fork-lift truck, indicated in figure 40, have pushed out the wall cladding. An interior bumper system, or floor chocks appropriately spaced from the wall, should have prevented such an accident.

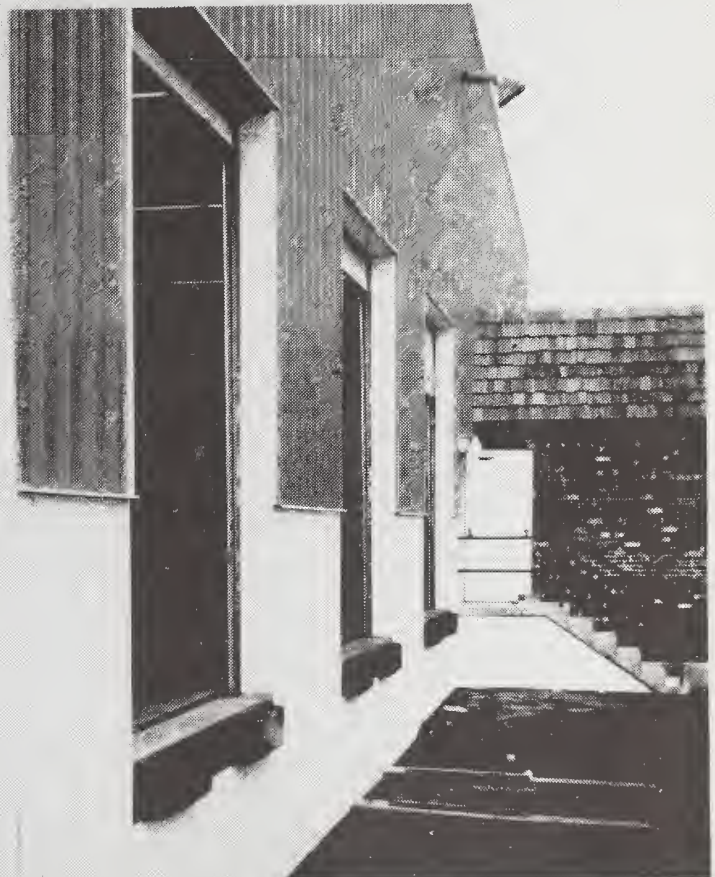
Fig. 39 - Loading dock
constructed of industrial
cladding and masonry. (E.2)

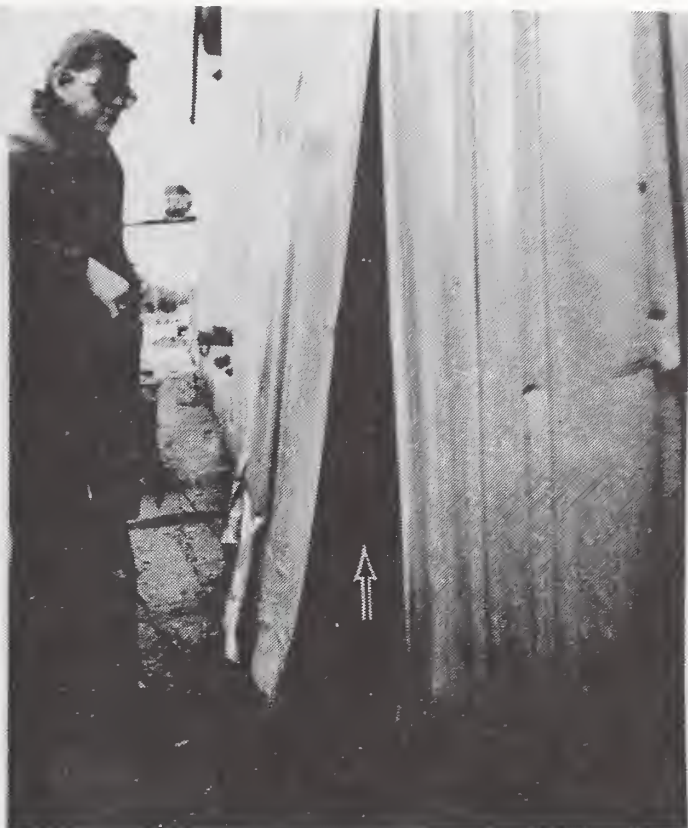
Fig. 40 - Wall panels
pushed-out from inside
building. Arrow indicates
prongs of forklift truck.
(E-2)

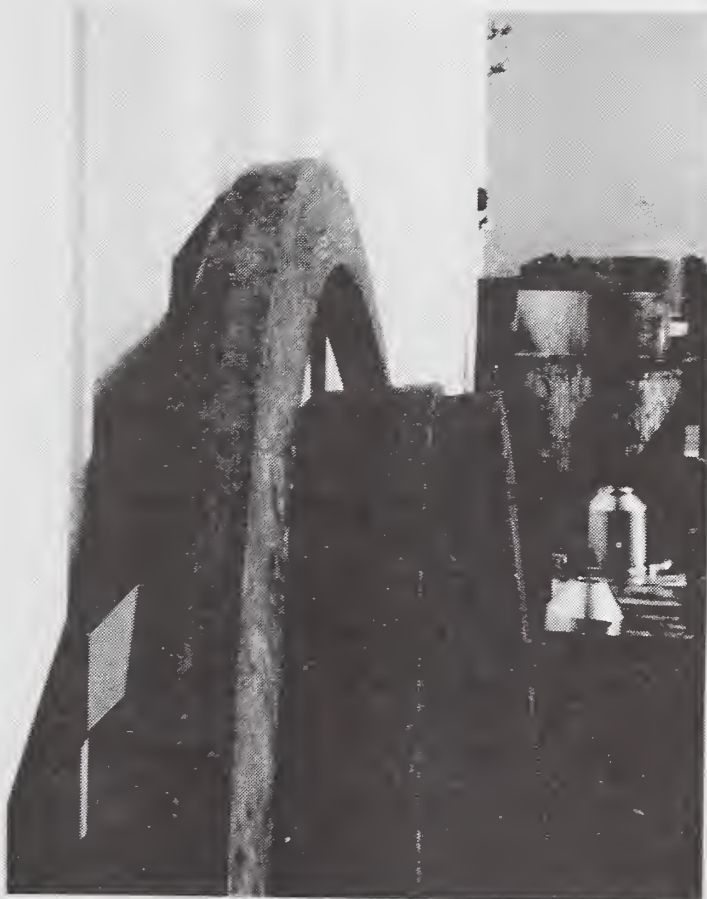
Fig. 41 - Plant storage
area with industrial
cladding wall used as
support. (E-2)

In the first example, several hundred feet of a manufacturing plant's exterior wall was used as a storage area. The massive units shown in figure 41 are supported only by the industrial cladding panels of the plant wall. Smaller units have been pushed against the wall at ground level, causing the cladding damage pictured in figure 42. The second example, a similar, albeit minor instance of negligence, is shown in figure 43. In lieu of a proper base for anchoring a door chain, a C-clamp has been attached to the cladding, distorting the panel profile.

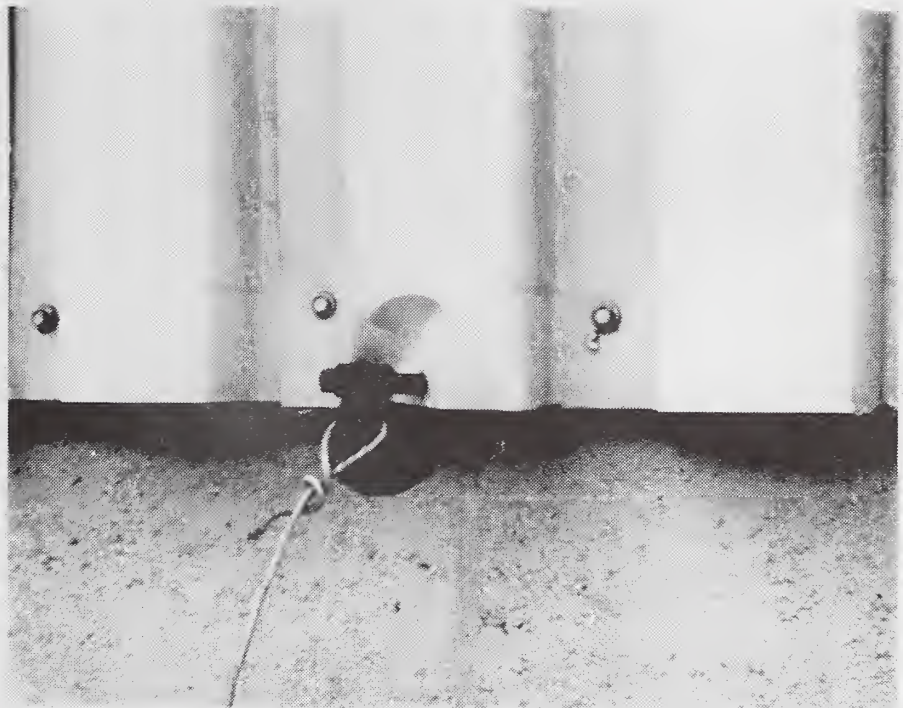
Fig. 43 - Distortion of cladding by attachment
of C-clamp used as anchor for door
chain. (E.2)
